Mtn View Aviation, LLC.
921 SE 47th Ave., Suite 2
Portland, OR 97215

MVA-177C10M&O
Installation and Maintenance Instructions for
Door Steward[™]
In Accordance with STC SA01120SE

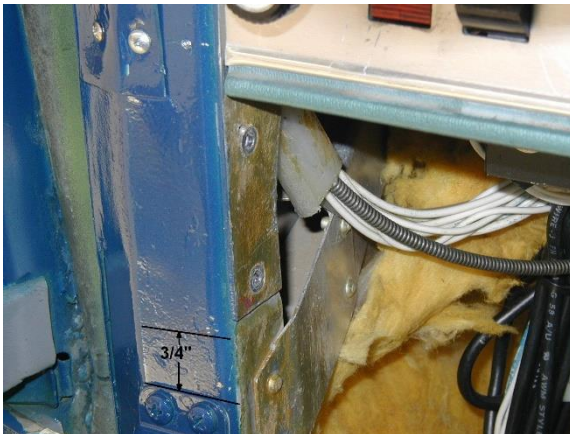
Figure 1

Figure 1: Shows a 3/4" mark made above the existing upper door stop bracket and both #5 existing rivets removed.

5. Using a #21 Drill remove the two 5/32" rivets located behind where the inboard flange of the airframe bracket is to be mounted. (Ref. **Figure 1**.)

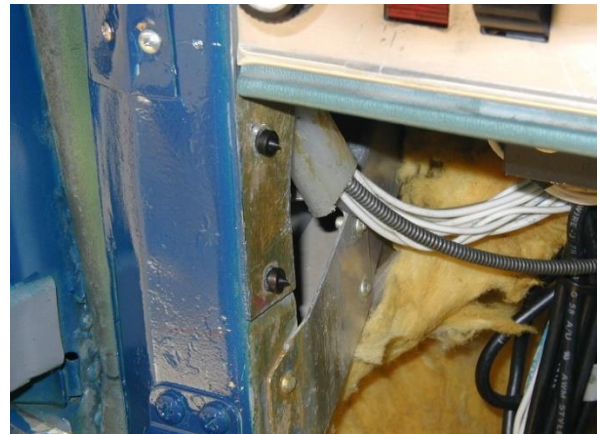
Figure 2

Error! Reference source not found.: Shows the 5/32" blind hole spotters inserted into the empty holes.

6. Place a supplied 5/32" blind hole spotter in each of the removed rivet holes. (Ref. **Error! Reference source not found.**) Position the airframe bracket into position, insuring the bracket is in full contact with the aft face of the door frame and transfer the hole locations to the airframe bracket by tapping with a small ball peen hammer on the bracket opposite the blind hole spotters location. Inspect the bracket to see that the blind hole spotters left a mark indicating the location to drill. The marked position for the #21 holes should be located diagonally aft and away from the predrilled #30 holes also located on this inboard flange. Drill the airframe bracket with the two #21 holes located.

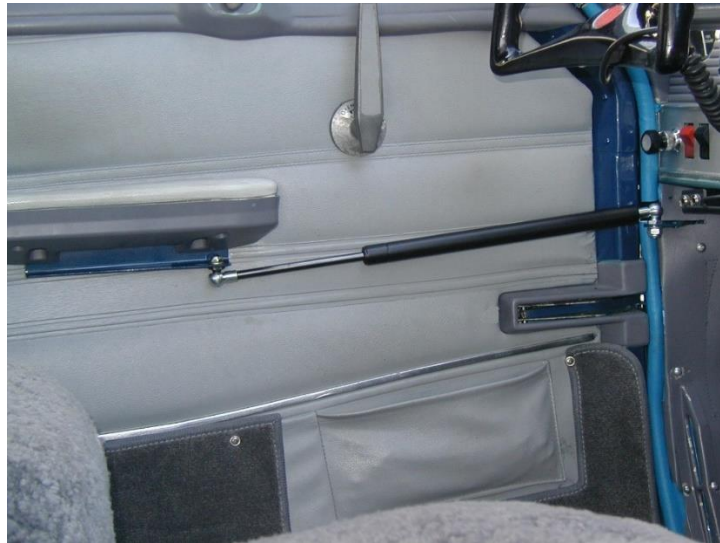
Figure 4. Installation Complete – Door Closed

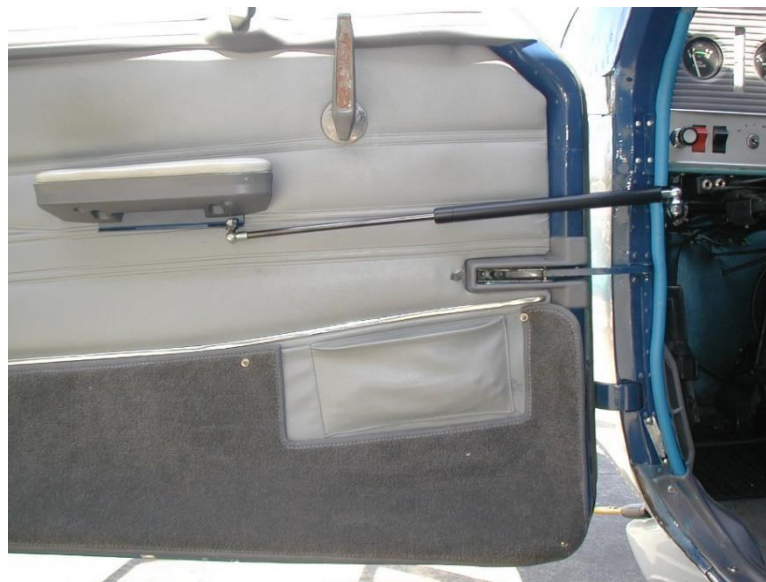
Figure 5. Installation Complete – Door Open
